UNDERSTANDING FAILURE IN FLEXIBLE PAVEMENT AND OPTIONS OF MAINTENANCE USING PAVEMENT CONDITION SURVEY

**Kufre Primus Okon, Enobong Okon Inyang, Edidiong Okon Mkpa,
Sunday Asuquo Saturday, & Ndifreke Sunday Ukommi**

Department of Civil Engineering, School of Engineering
Akwa Ibom State Polytechnic, Ikot Osurua, Ikot Ekpene
Akwa Ibom State

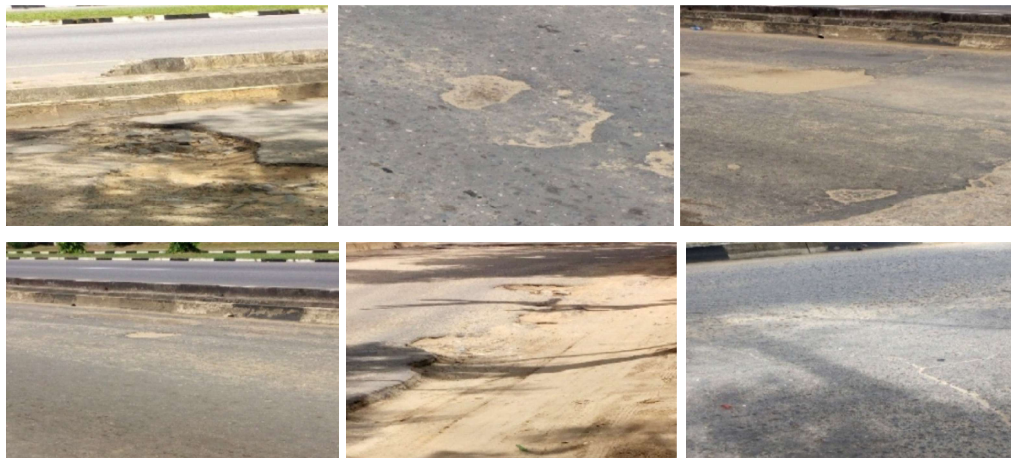
Fig. 2: Various failed sections of Edet Akpan Avenue

A comprehensive visual survey of pavement surface was conducted by walking through the study surface area and closely observing, identifying, and recording the defects on failed pavement sections. The data collected from the field survey of the existing pavement surface failures were analysed. The measured and observed states of failures with different levels of severity are given in Table 1 and figure 2.

Distress	Section A	Section B	Section C
Rutting	Heavy	Moderate	Light
Depression	High	High	Moderate
Potholes	Low	Moderate	Low
Cracking	High	Moderate	Moderate
Ravelling	High	High	High
Polishing	High	Moderate	Low
Patching	Moderate	High	Low

The test results from the dynamic cone penetration test revealed that the thickness of the base layer varied between 180-210mm whereas the sub-base ranged from 205-350mm, but the specification for the project required 250mm and 400mm respectively for the base course and sub-base course layers. Using empirical relationships, the California Bearing Ratio (CBR) were determined from the DCPT results, the average CBR values of the base, sub-base and embankment materials are 67%, 37% and 18% respectively. The results illustrated that the base materials do not comply with the specifications (i.e. $\text{CBR} \geq 80\%$). While the sub-base and embankment materials barely complied with the specifications. Analysis on the test result from the DCPT revealed that there was no clear distinction between the quality of the base and the sub-base layer material since the lateritic gravelly sandy soils with trace of clay were practically dumped on the sub-base layer.

The asphalt sample carried for the Asphalt Marshall test in Table 5 revealed that, 70mm thickness asphalt was used. The Asphalt Marshall Stability and Flow test was carried out according to the specifications of ASTM D1559-89, and the results revealed that the average stability and flow from the three samples in the different sections was within acceptable range with the specification of the project, and it is sufficient to resist plastic deformation. The extraction test (table 4) on the other hand revealed that the average percentage binder content in the asphalt concrete was too low and that has greatly affected the durability of the asphalt concrete resulting in the ravelling observed on the road pavement.

The maintenance option that was considered appropriate for this research was pavement overlay. Considering the legend in the pavement condition rating which summarised the overall pavement condition, the condition rating was 51 which falls between 40 and 80 which is the range for pavement overlay.
